Manhole Inspection Summary

Manhole # S23M__007MH

Insp Date: **6/19/08 3:45 PM**

Location Address: **425 S Vincent St**

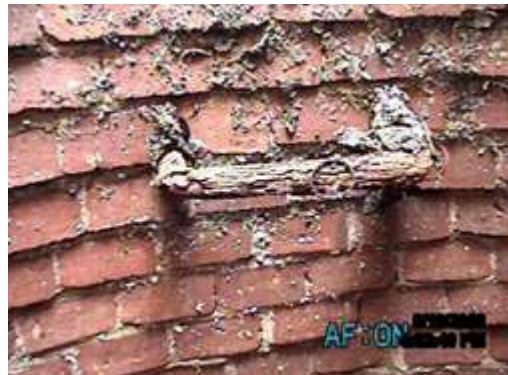
Defect 3

☒ **Corroded**

corroded rungs

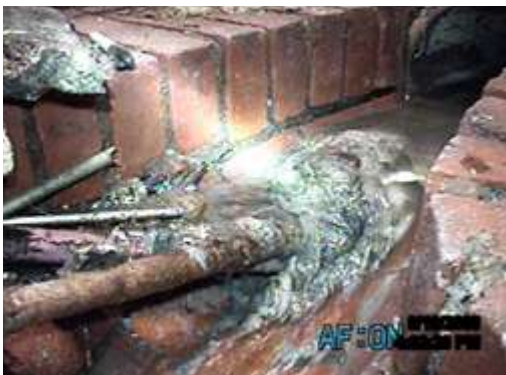
Defect 2

Condition: ☐ Sound ☐ Cracked ☐ Root Intrusion ☐ Deteriorated ☐ Leaks ☒ **Debris**

debris in channel

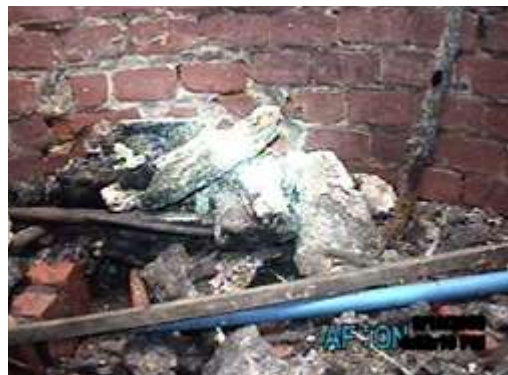
Defect 1

Condition: ☐ Sound ☐ Cracked ☐ Root Intrusion ☐ Deteriorated ☐ Leaks ☒ **Debris**

debris on bench and channel

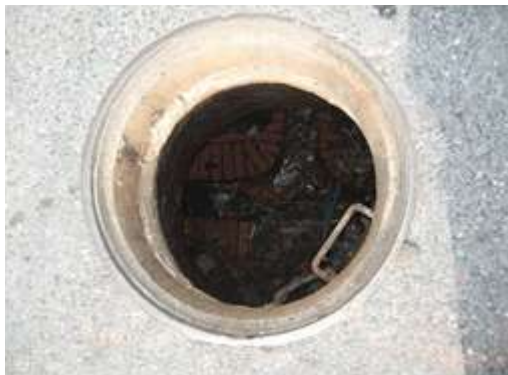
Defect 4

Offset: **2** (in.)

frame offset

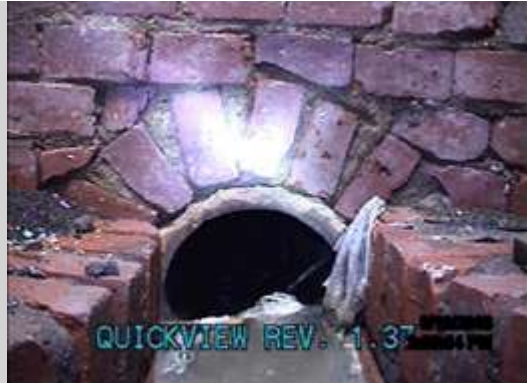
12 O'Clock Outflow

Pipe Height: **8.4** (in.) Rod and Bar (Angled)
Pipe Material: **Clay** ☐ Pipe Lined
Invert Depth: **7.61** (ft.) Flow Characteristics: **Slow**
Deposits: ☐ None ☐ Mud ☐ Sludge ☒ **Debris** ☐ Grease
Silt Depth: **4** (in.) Deposits Extent: **Medium**
Infiltration: **Evidence** Pipe Seal Cond: **Unknown**

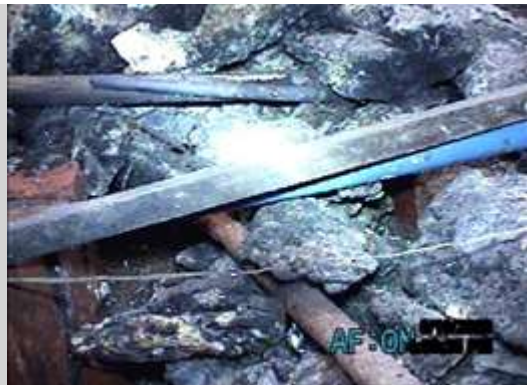
3 O'Clock Inflow

channel blocked by debris

Pipe Height: **3.6** (in.) Direct (Angled)
Pipe Material: **Clay** ☐ Pipe Lined
Invert Depth: **7.33** (ft.) Flow Characteristics: **None**
Deposits: ☐ None ☐ Mud ☐ Sludge ☒ **Debris** ☐ Grease
Silt Depth: **7** (in.) Deposits Extent: **Heavy**
Infiltration: **None** Pipe Seal Cond: **Unknown**

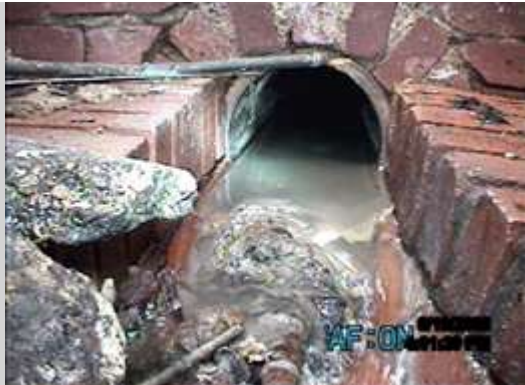
9 O'Clock Inflow

Infiltration: **Evidence** Pipe Seal Cond: **Unknown**
